EVALUATION OF LUMBER FROM DECONSTRUCTED PORTLAND RESIDENTIAL BUILDINGS

Abstract. Portland, OR, was the first US city to implement a deconstruction ordinance in 2016. Although salvaged lumber from deconstructed dwellings can have high demand, the market for small-sized lumber is near saturation. New applications for this material are required for market development, industry diversification, and the possible expansion of the deconstruction ordinance. Its use in mass timber is an option, but presently no wood property information exists for lumber from deconstructed dwellings, inhibiting its use for structural purposes. Density and dynamic MOE (E) of 265, 38 mm × 89 mm (2 × 4) pieces of salvaged Douglas-fir (*Pseudotsuga menziesii*) lumber were determined using a Metriguard Model 340 E-Computer. Additional data collected included sample dimensions, weight, and visual appearance. Over 50% of samples had a calculated stiffness comparable with the highest structural design grade for Coastal Douglas-fir lumber. The presence of knots and damage, present in 66% and 59% of boards, respectively, would likely downgrade boards despite acceptable stiffness. Results show that 96% of samples wer

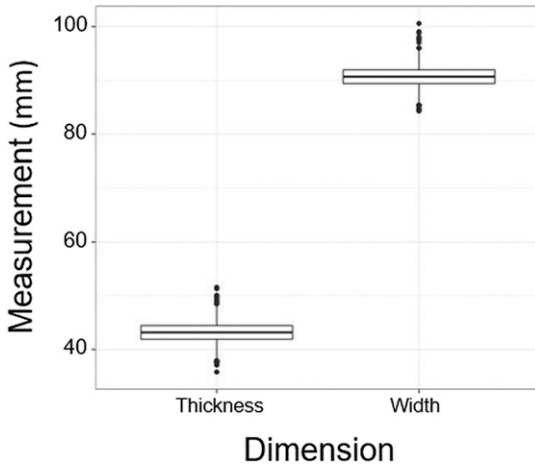
Figure 2. Thickness and width distributions (mm) for 483 pieces of salvaged lumber.

for thickness and width were 15.8 mm and 16.3 mm, respectively (Fig 2). Like standard lumber sizes, the differences in dimensions among boards also exceeded the permitted variation in lumber described by the current grading rules.

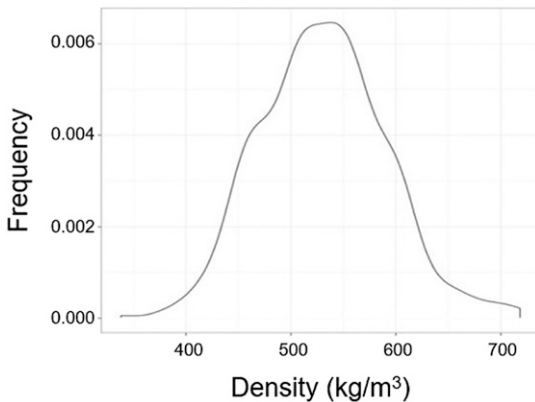
Figure 3. Frequency distribution for the density (kg/m³) of 483 salvaged lumber pieces.

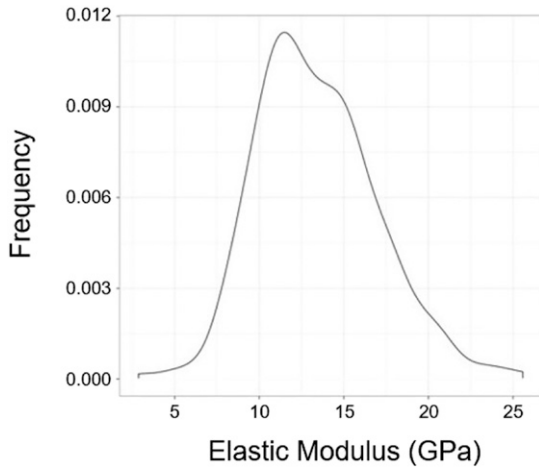
Figure 4. Frequency distribution of dynamic MOE (E) for 265 pieces of salvaged lumber.

layup grade of E3, which required laminations in the major direction to have an *E*-value not less than 8.3 GPa, with 96% of the 265 samples meeting the minimum requirements (Table 5). Distribution of *E*-values is shown in Fig 4. Summary statistics for salvaged lumber graded with the Metriguard are shown in Table 6.
